Manhole Inspection Summary

Manhole # S41II_013MH

Insp Date: **1/22/08 12:43 PM**

Location Address: **1600 HARFORD RD**

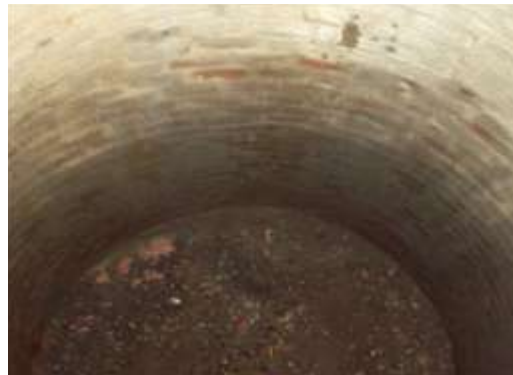
Defect 1

Count: **4** Missing: **4** ☒ **Corroded**

STEPS MISSING

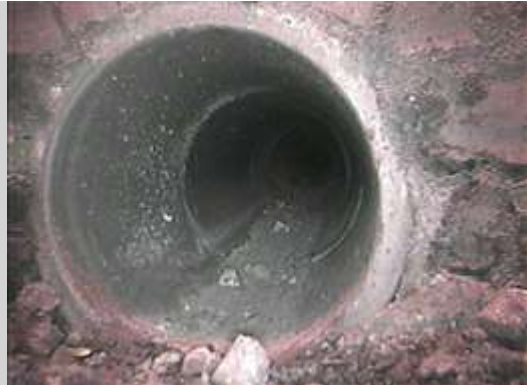
12 O'Clock Outflow

8 in. Circular Gravity Sewer
Pipe Out @ 12 O'Clock

Deposits: ☐ None ☒ **Mud** ☐ Sludge ☐ Debris ☐ Grease

Silt Depth: **0** (in.) Deposits Extent: **Light**
